The COAST GUARD Journal of Safety & Security at Sea
PROCEEDINGS

WINTER 2018

Subchapter M
Towing the line

Vol. 75, Number 3

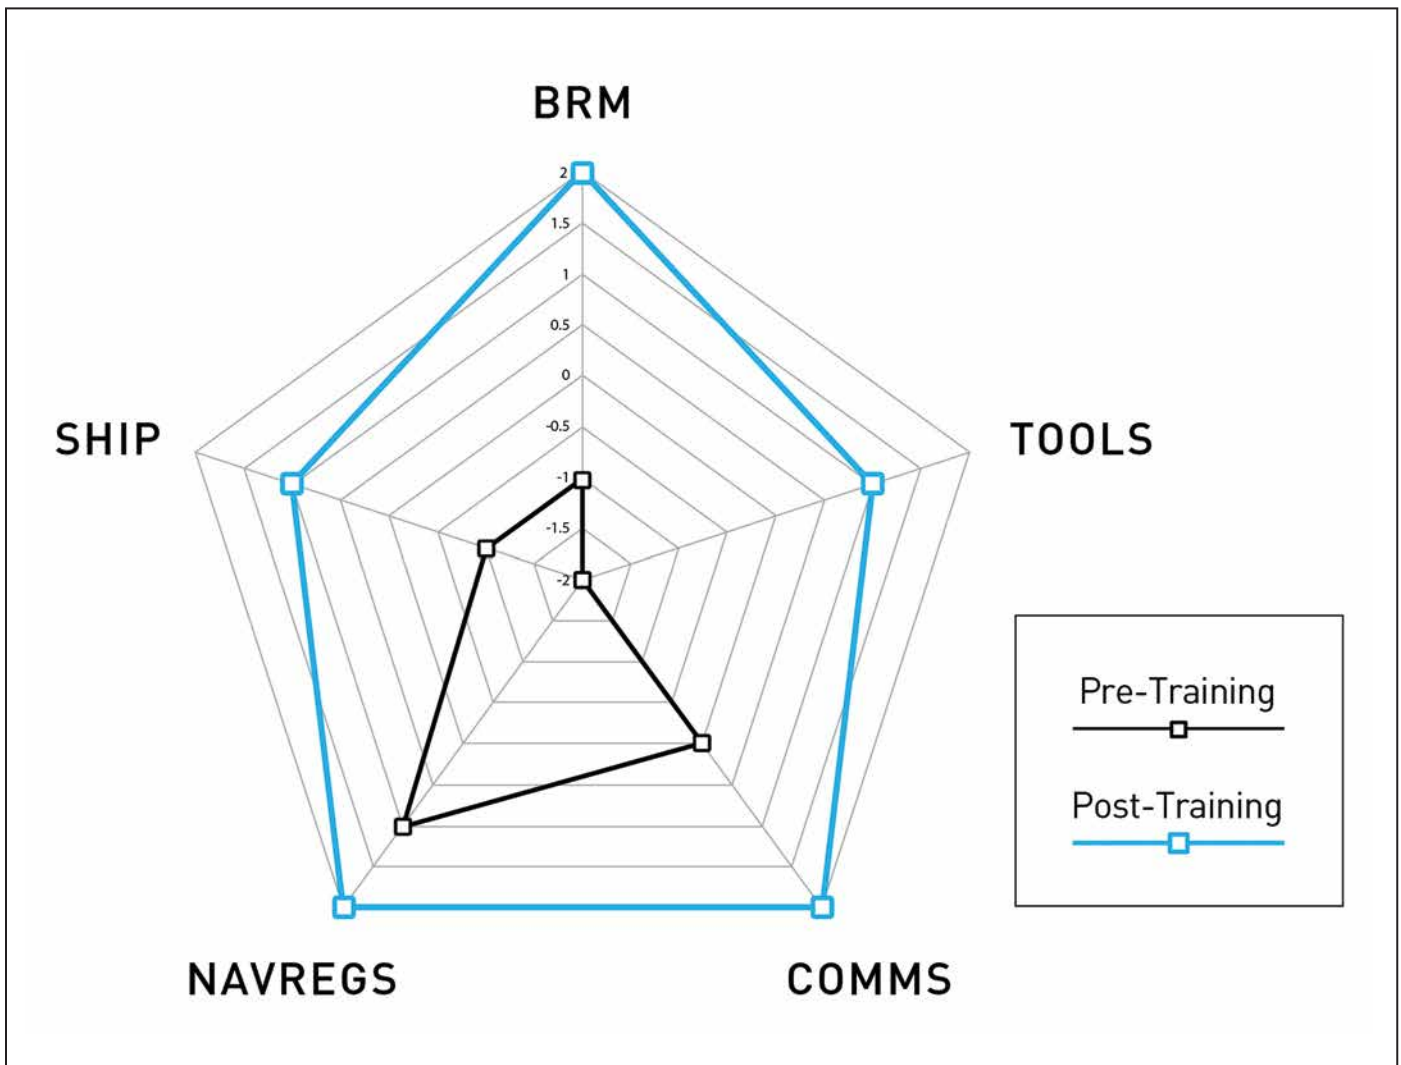
Diagram indicating areas of examination in the NSAP assessment. A detailed report identifies performance gaps so marine companies can create an appropriate training plan to close those gaps and improve the safety of marine operations. Figure courtesy of NSAP

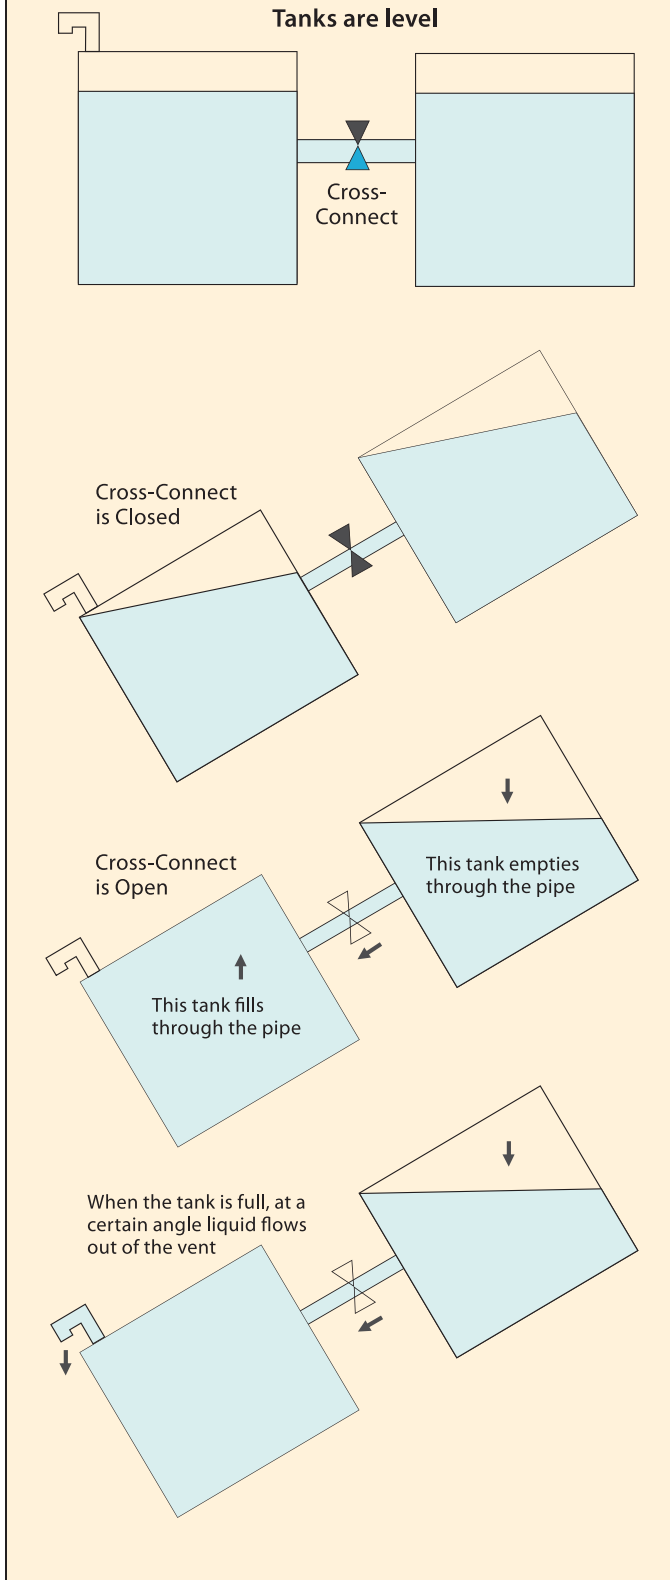
Hydrostatic Balancing Example

Illustration from the U.S. Coast Guard January 18, 2006, report *Investigation into the Circumstances Surrounding the Sinking of the Tug Valour*

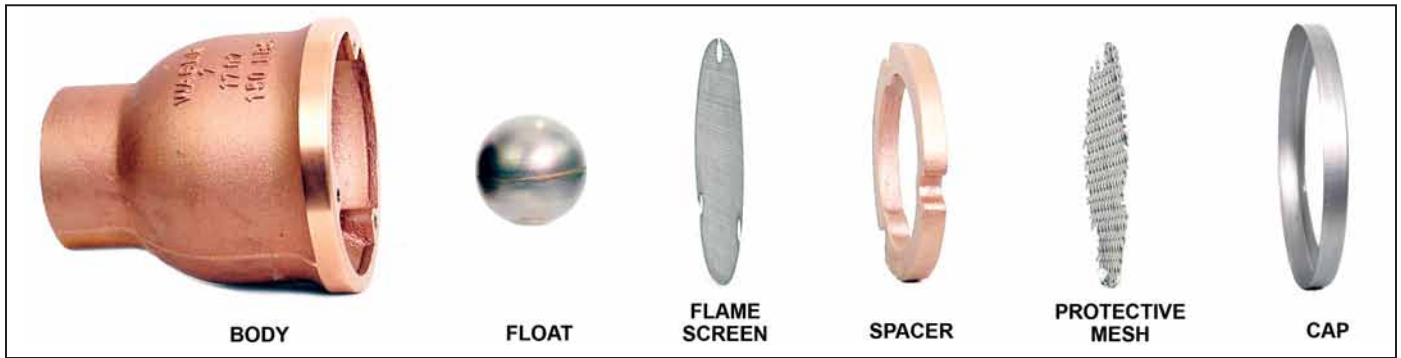
An inverted vent check valve protects tanks and bulkheads from pressure build-up during loading and unloading of liquid or dry cargo and assures maximum efficiency during operations. The ball float prevents contamination of the tank cargo from sea water during heavy seas. Illustration courtesy of Wager Company USA

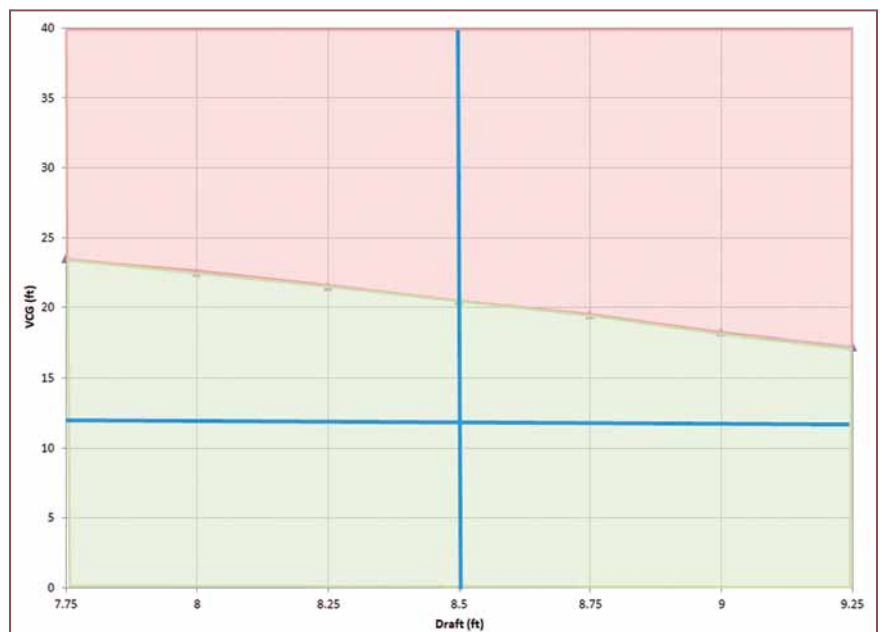
Limiting vertical center of gravity curve example for Hull 1. Coast Guard graphic by Ensign Erin Morgan

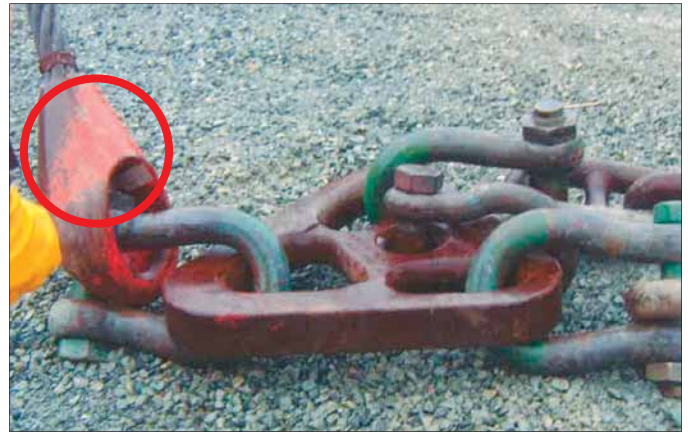
Arrangement of critical towing components in the yard in Dutch Harbor, Alaska, just prior to the departure on the accident voyage. The red circle indicates the critical component that failed, leading to the loss of the tow on the morning of December 27, 2012. Coast Guard photo

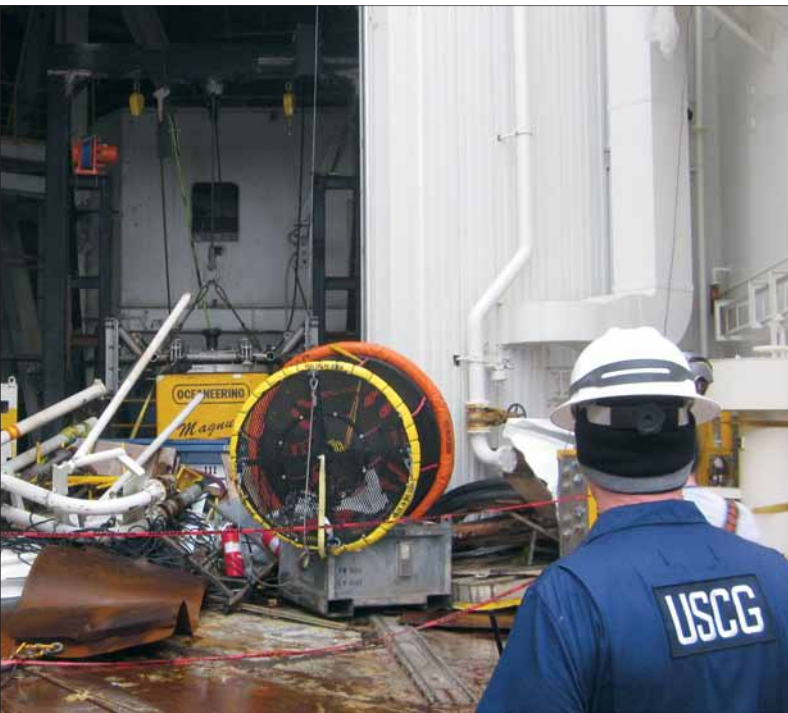
A Coast Guard inspector surveys damaged parts and equipment aboard the storm-damaged mobile offshore drilling unit *Kulluk* in Kiliuda Bay, Alaska, on January 10, 2013, after it went aground on Sitkalidak Island during a Gulf of Alaska winter storm on December 31, 2012. Coast Guard photo
